RE: Landfill 2 Closure Report

Landfill 2 **Construction Closure Report**

Orrington Remediation Site
Orrington, Maine

December 2017

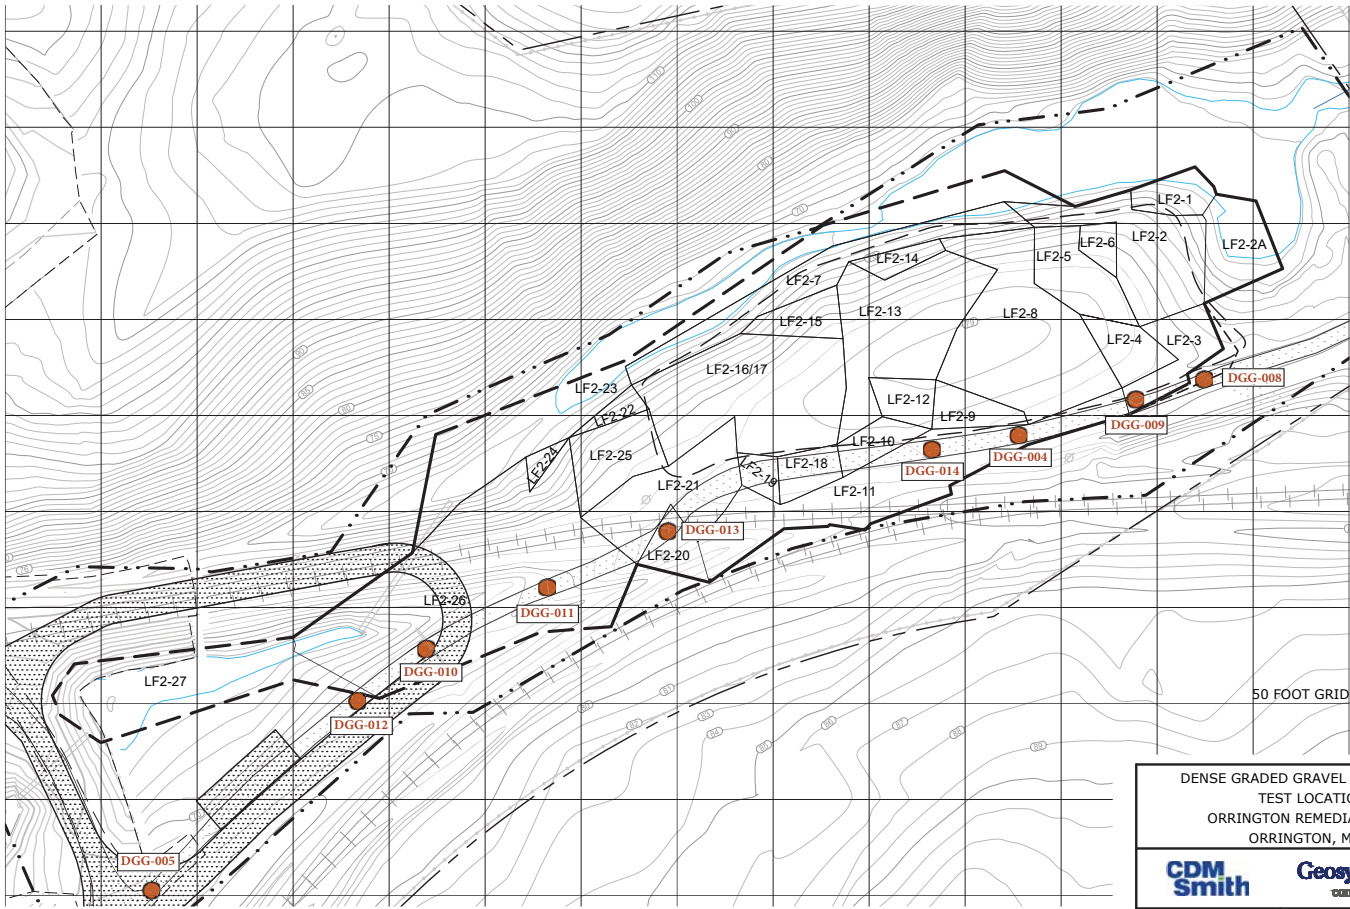
DECEMBER 2017
Figure: 4-2

1. Proctor DGG-002 is a QA sample.
2. The lift of DGG was 6 to 12 inches.
3. DGG-001 through 003 were 2 inch tests taken along the access road south of Scrap Metal Yard. DGG-005 through 007 were 4 inch retests in the same locations of DGG-001 through 003. Tests were not 6 inch tests due to the compaction of the 6 inch lift in these locations.
4. The moisture content was out of range for many of the tests performed due to dry conditions at the source and on site. Areas were considered to be acceptably compacted based on the percent compaction.

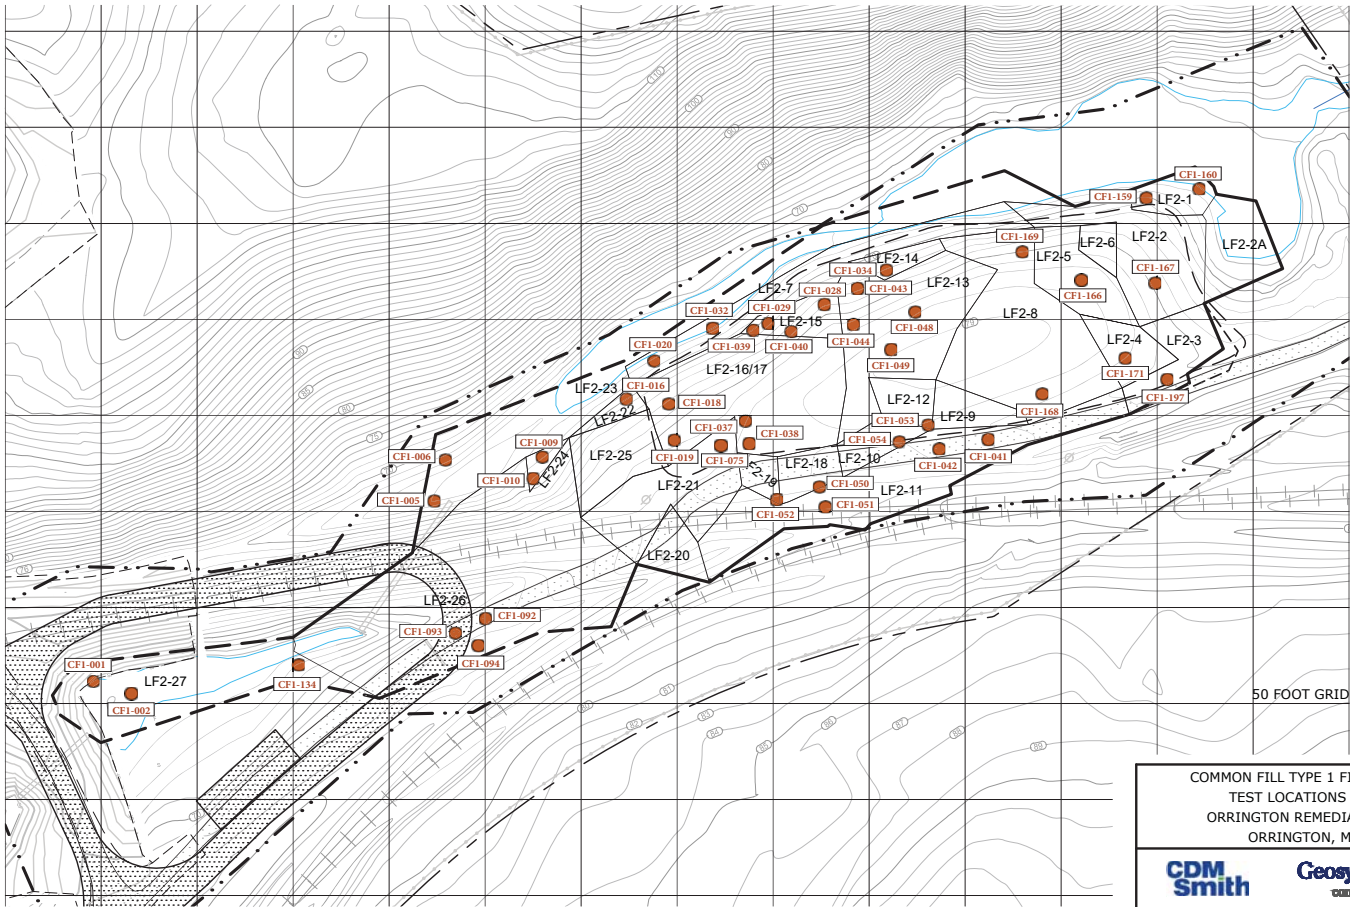
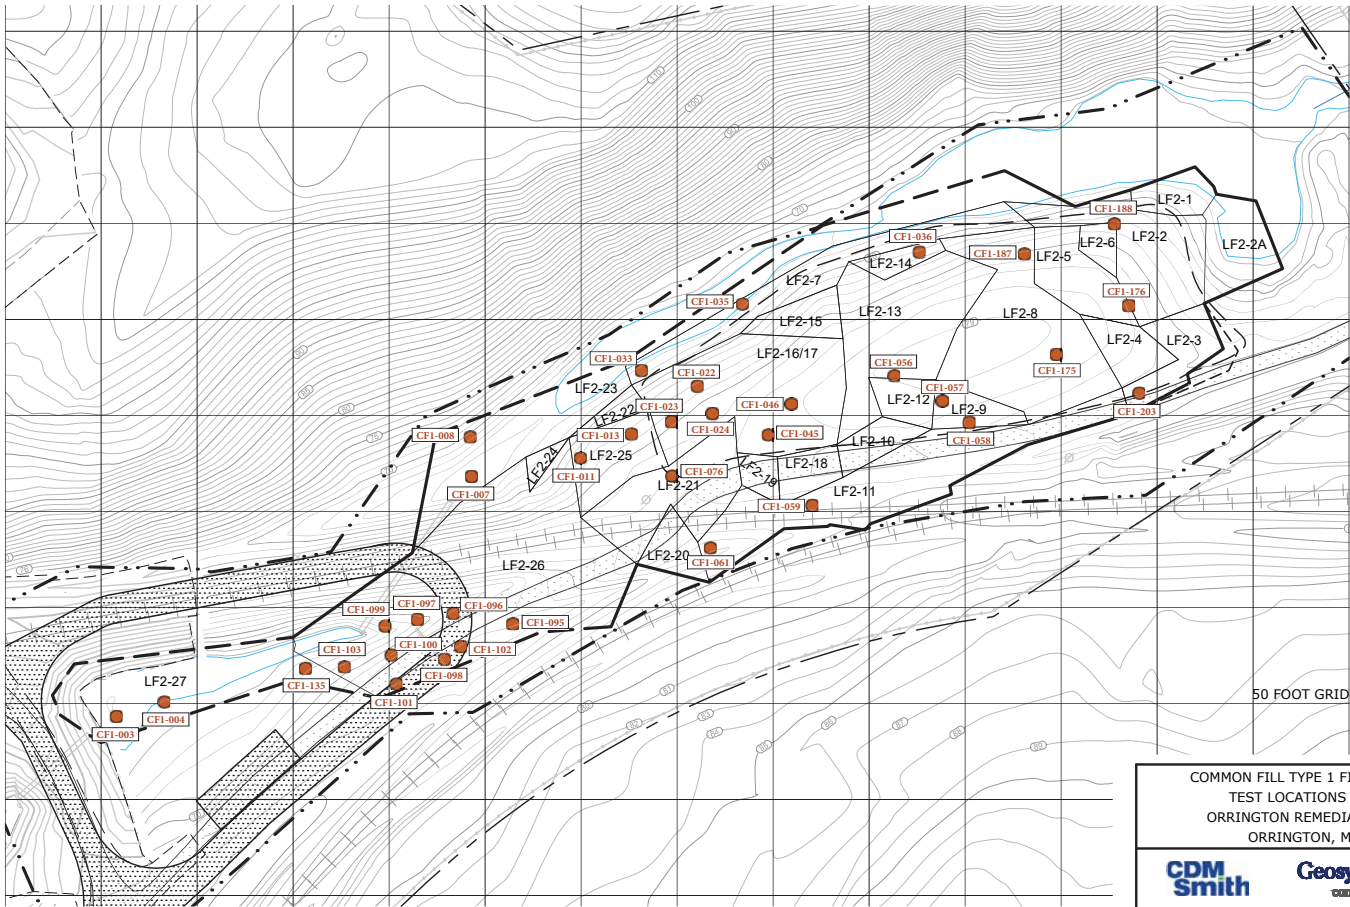
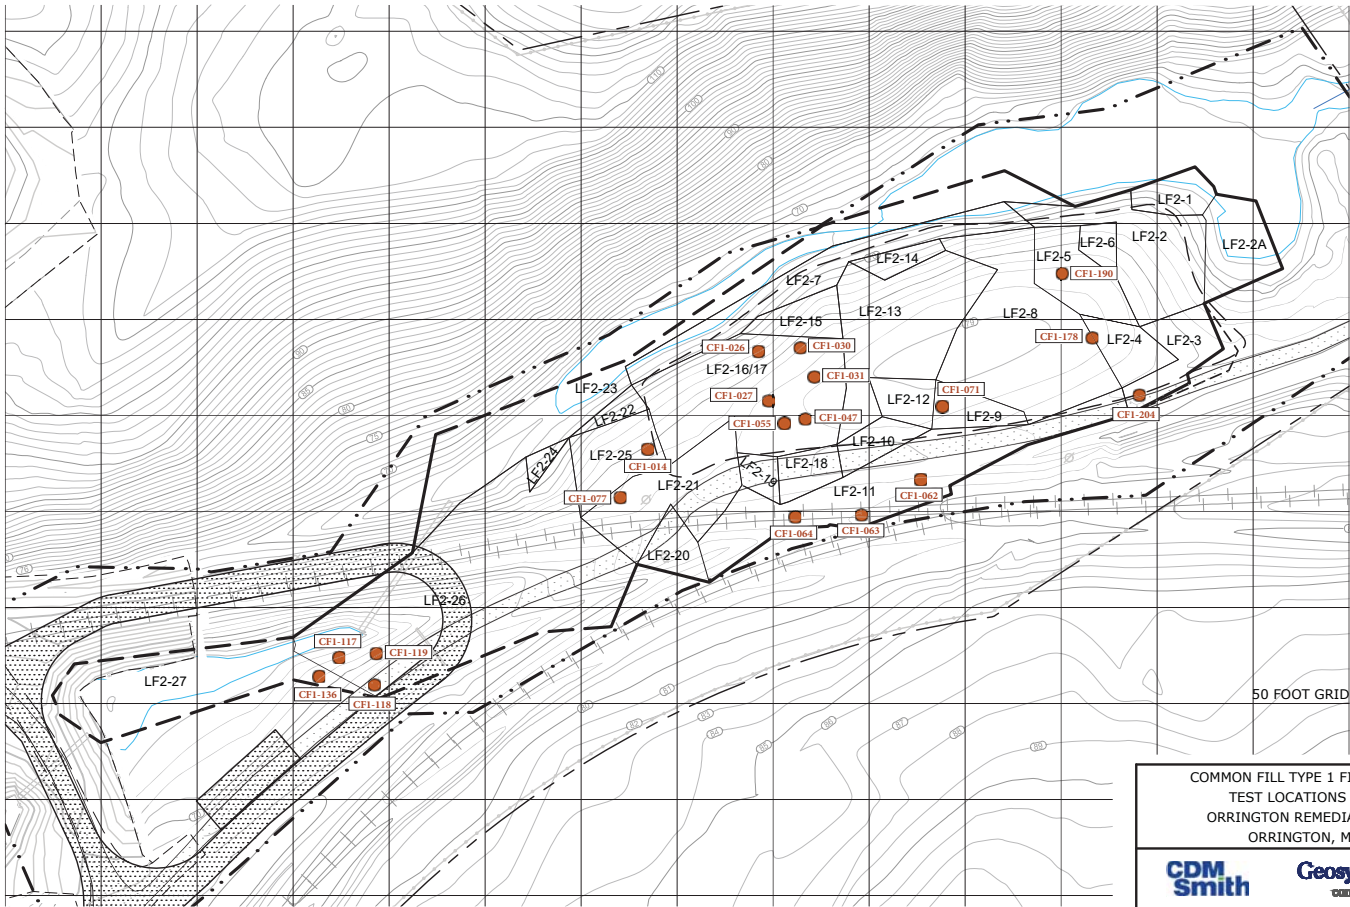
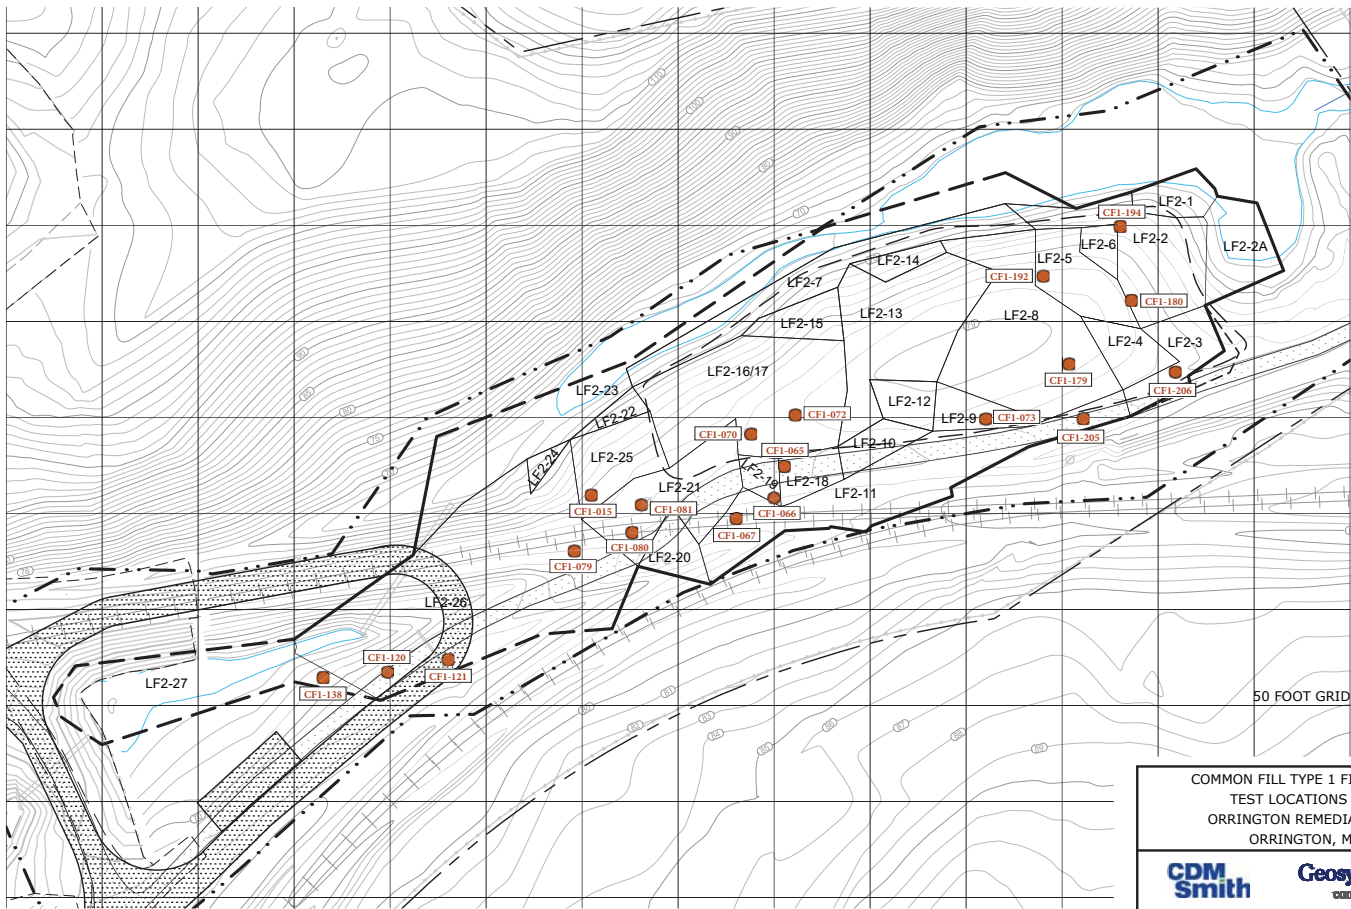
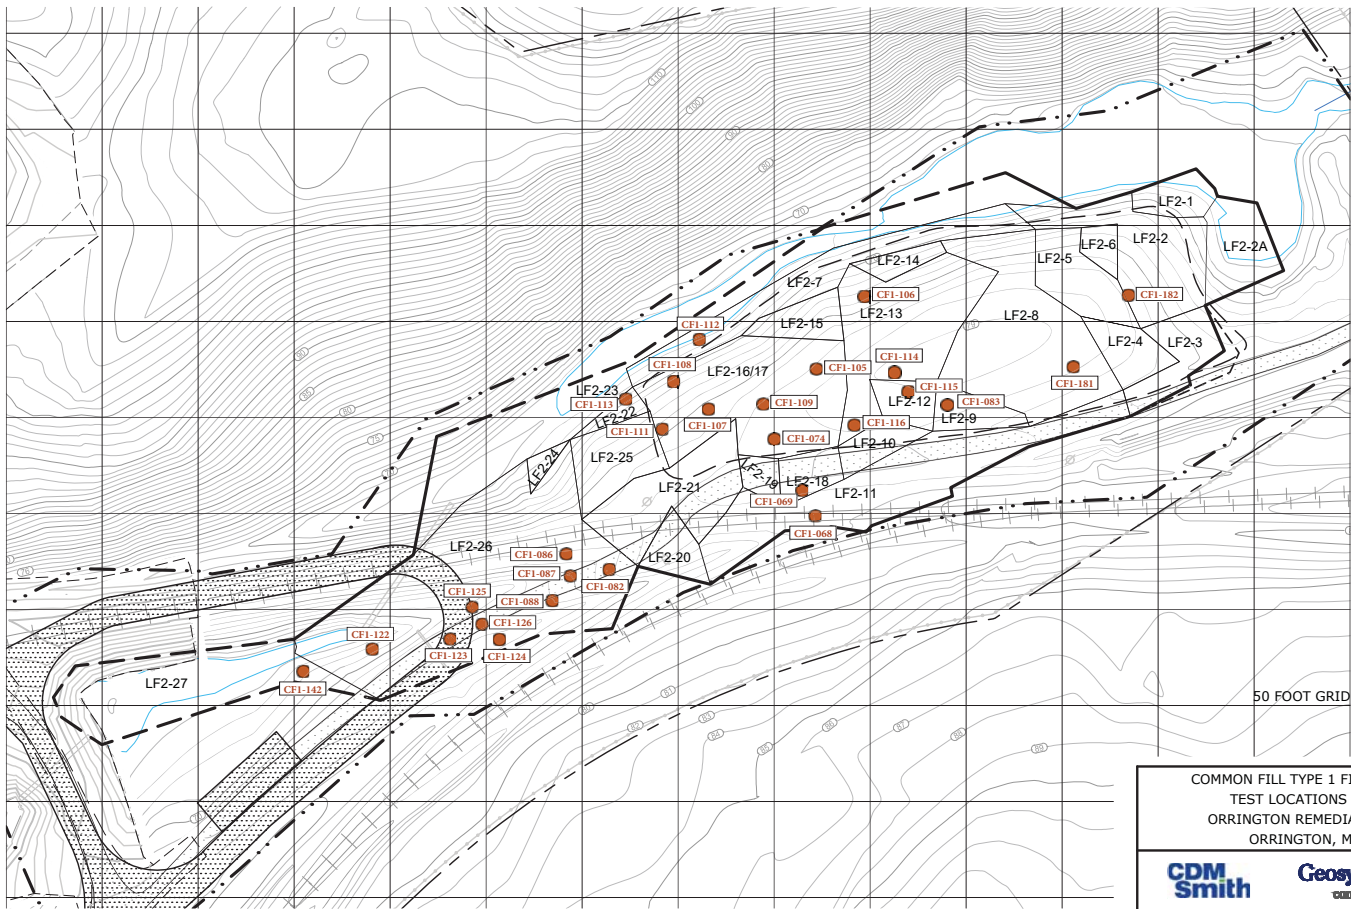
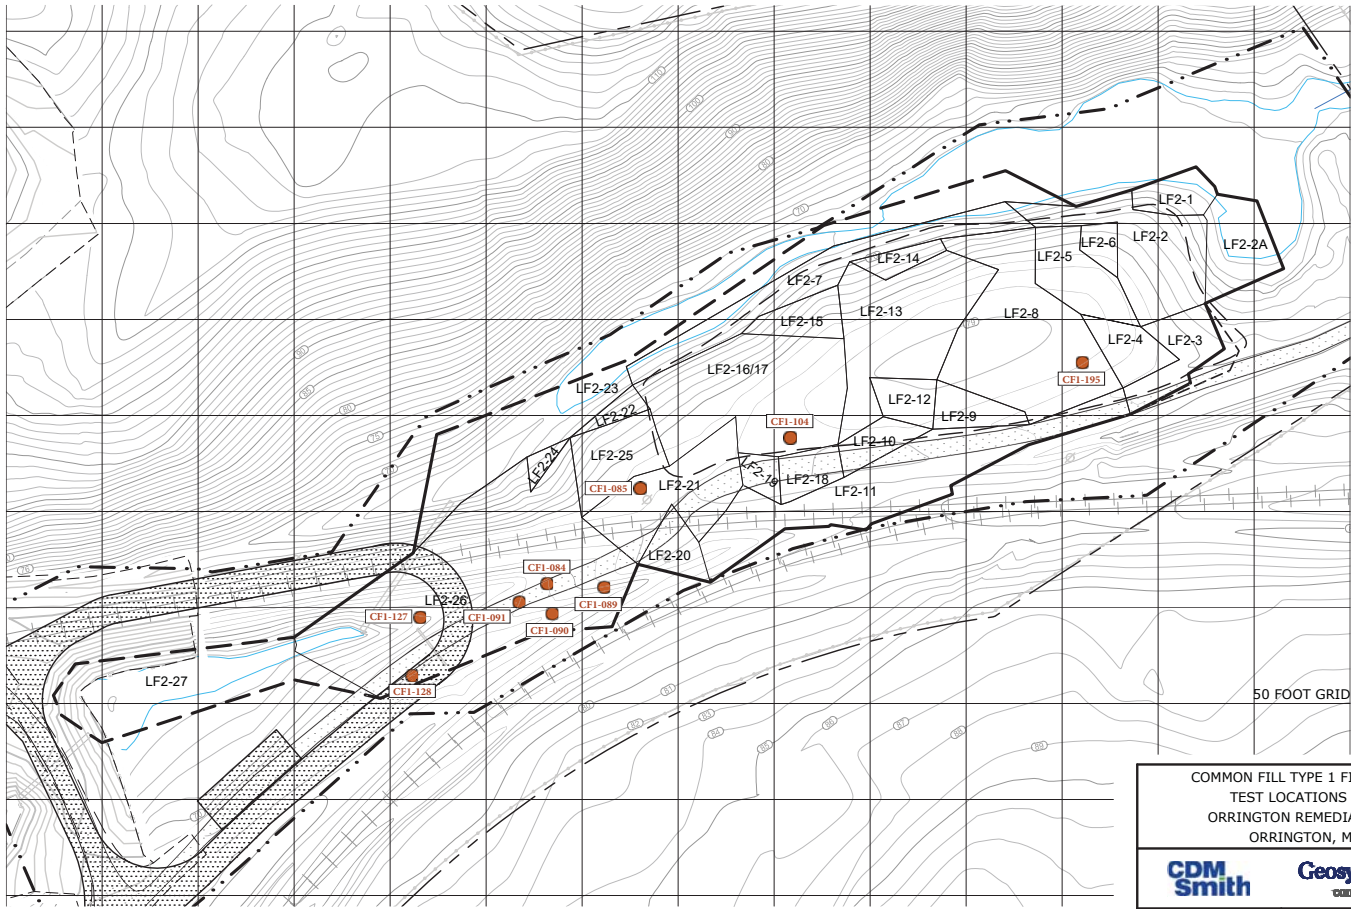
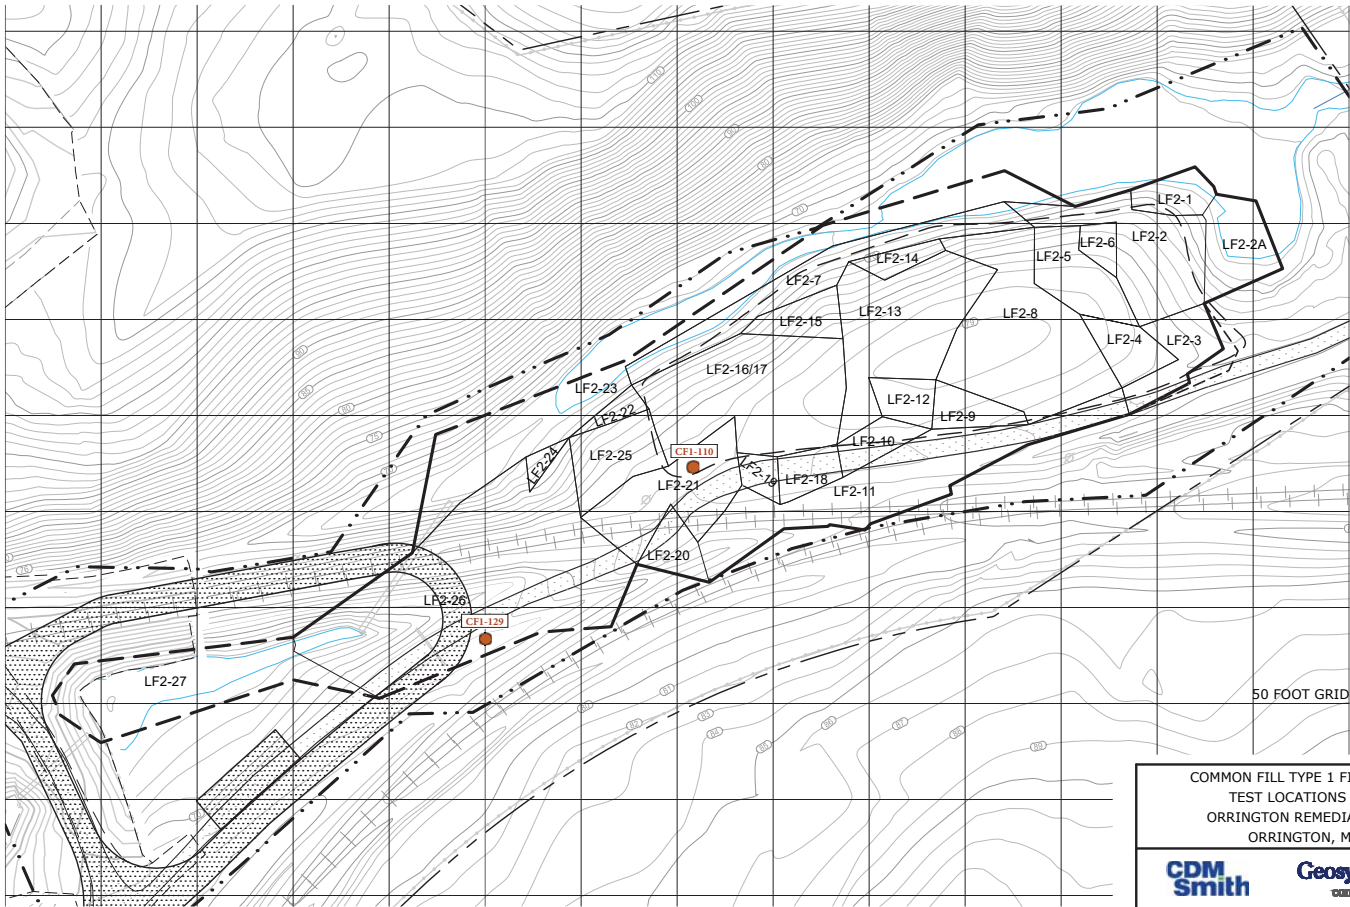
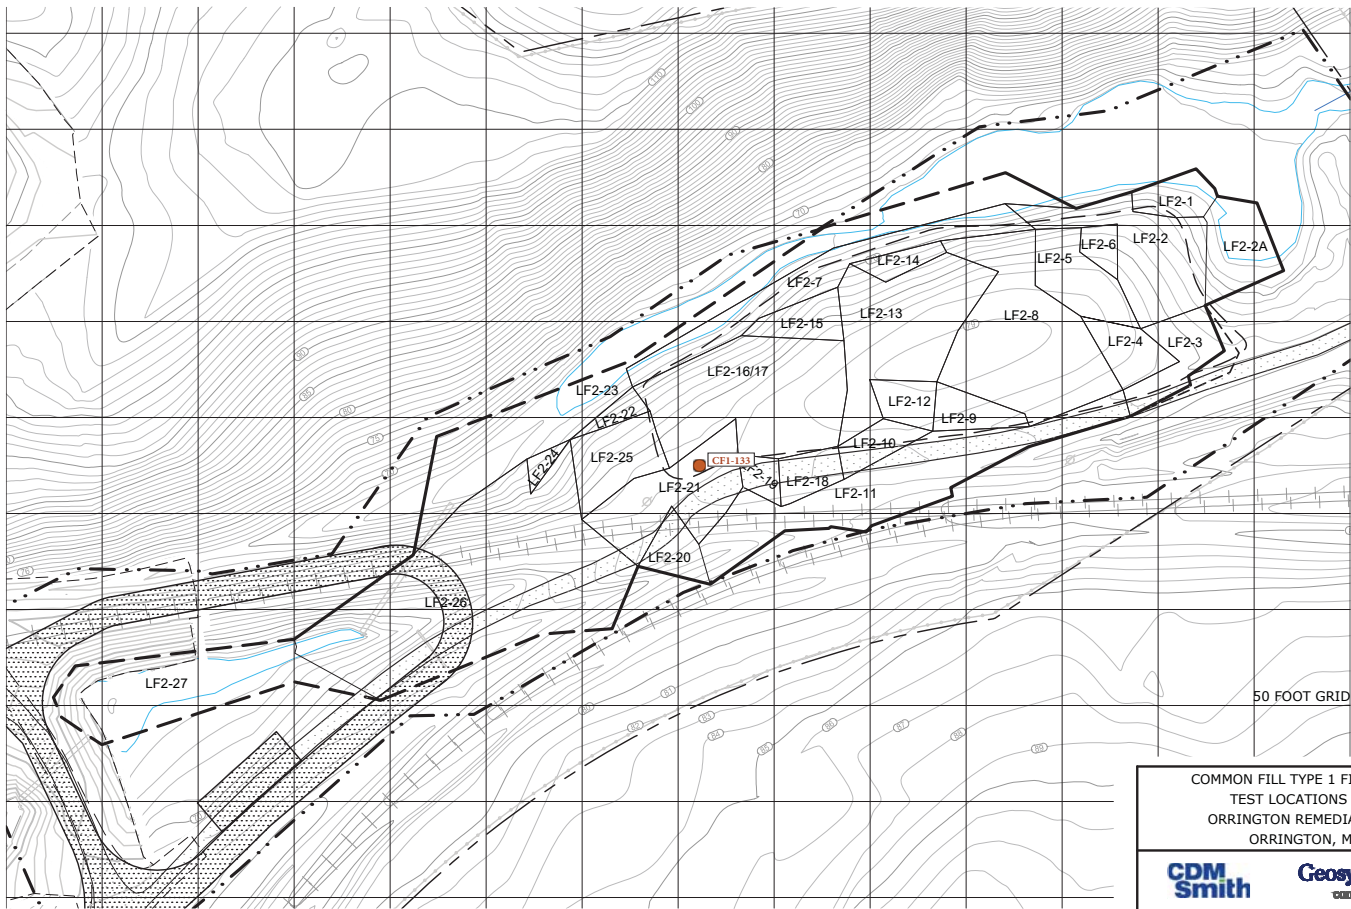
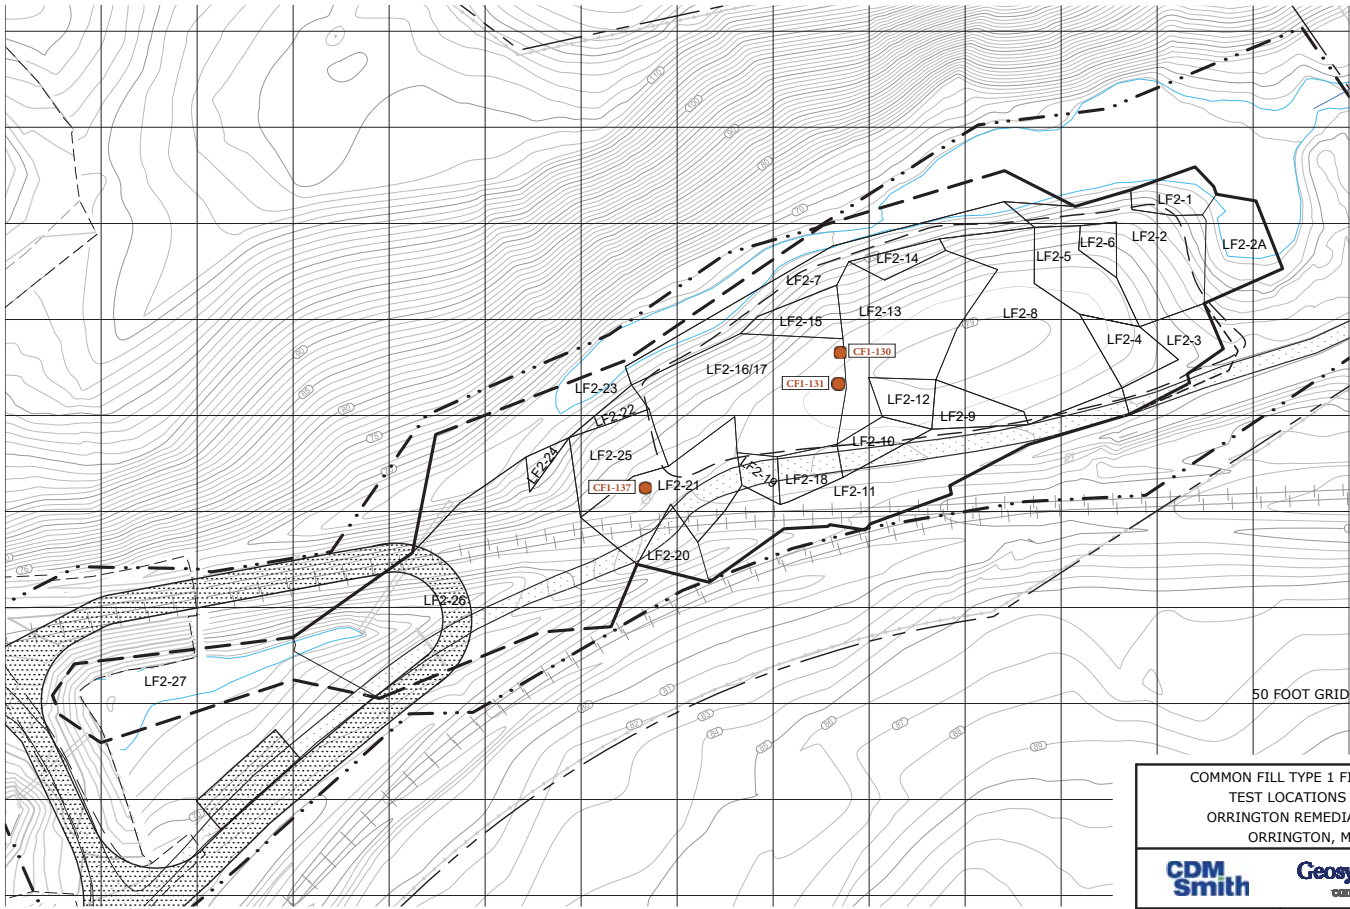
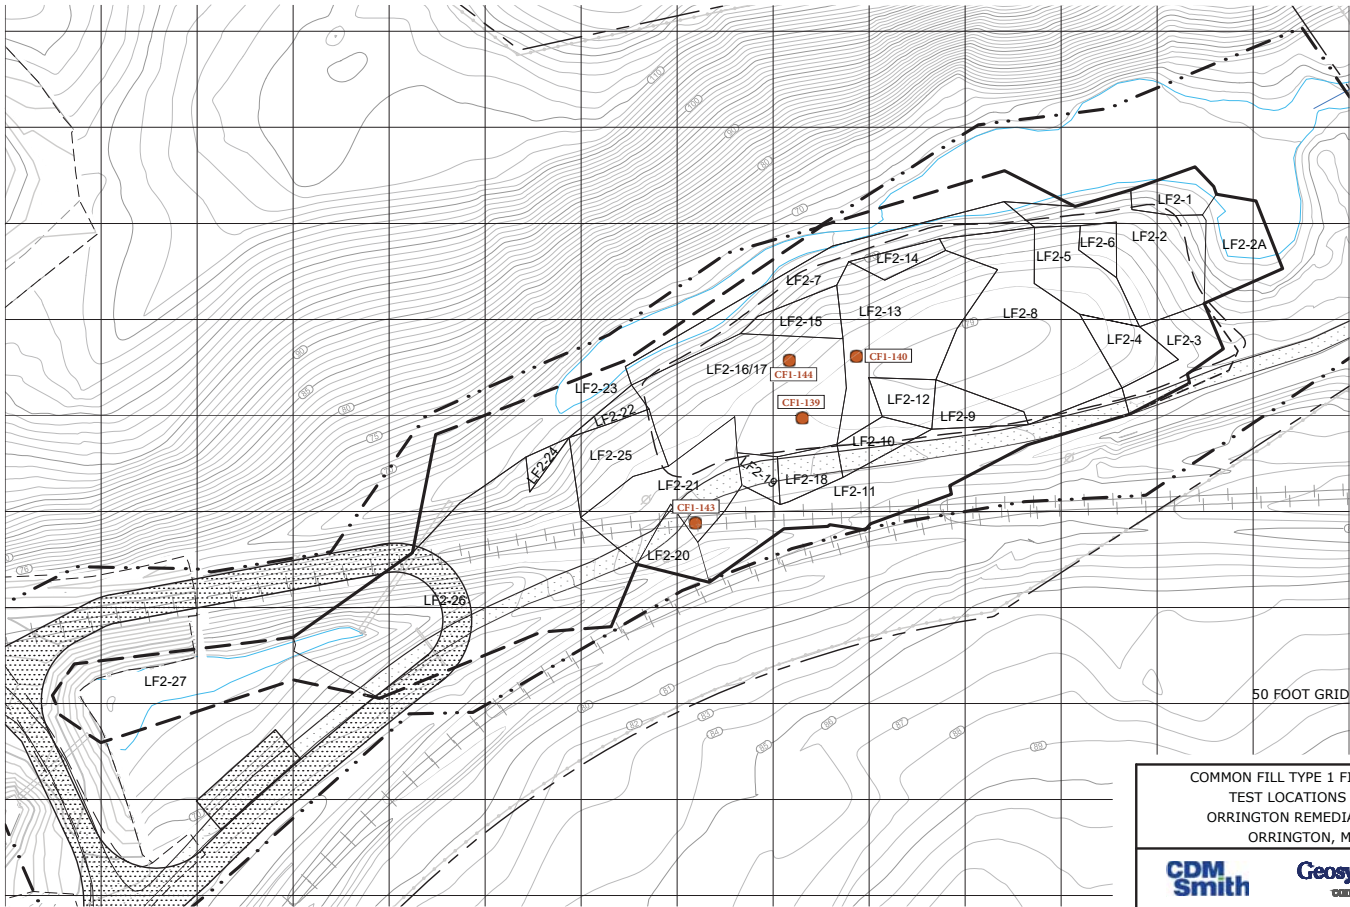
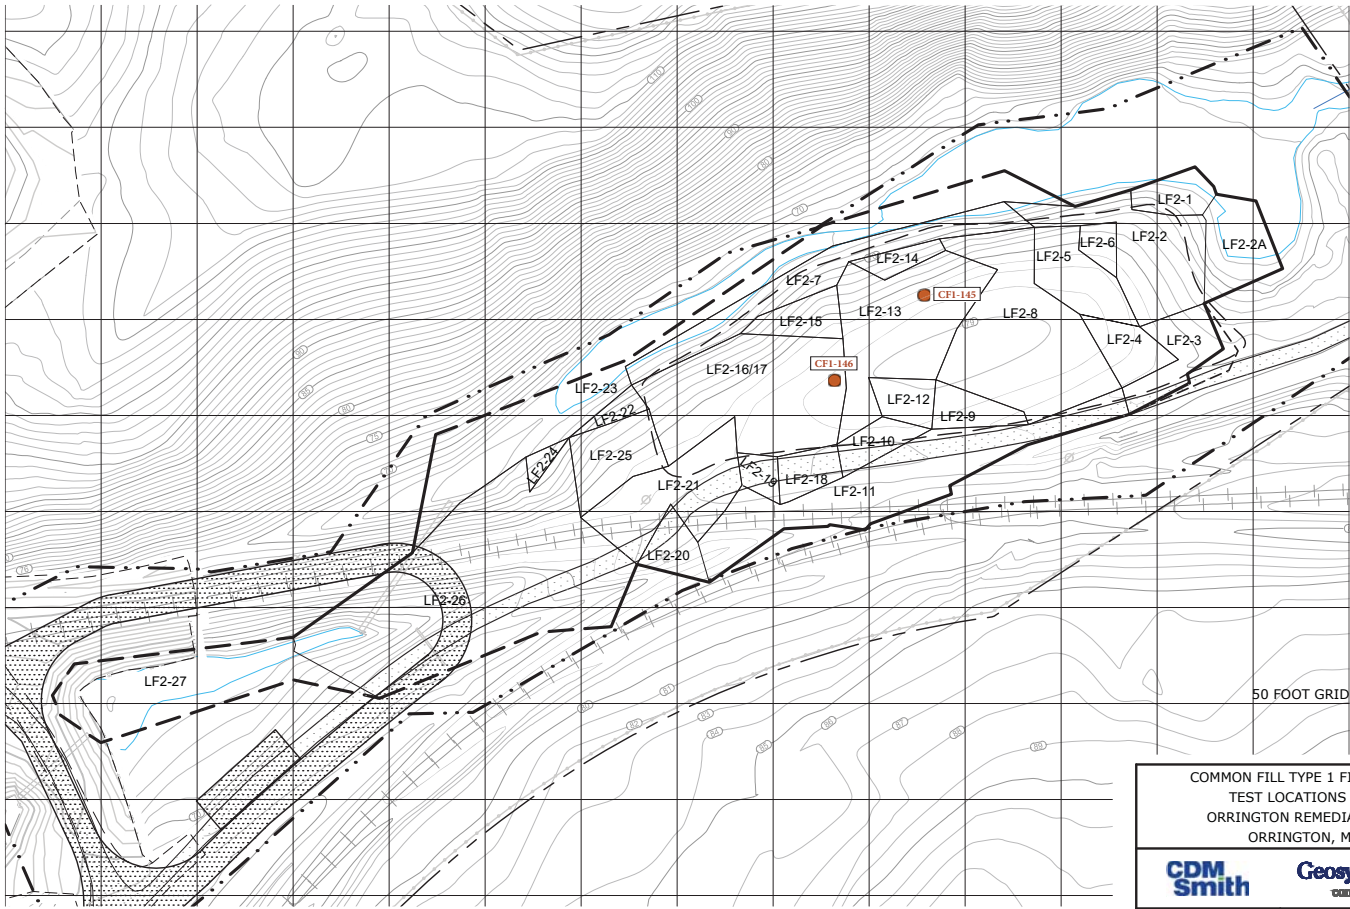
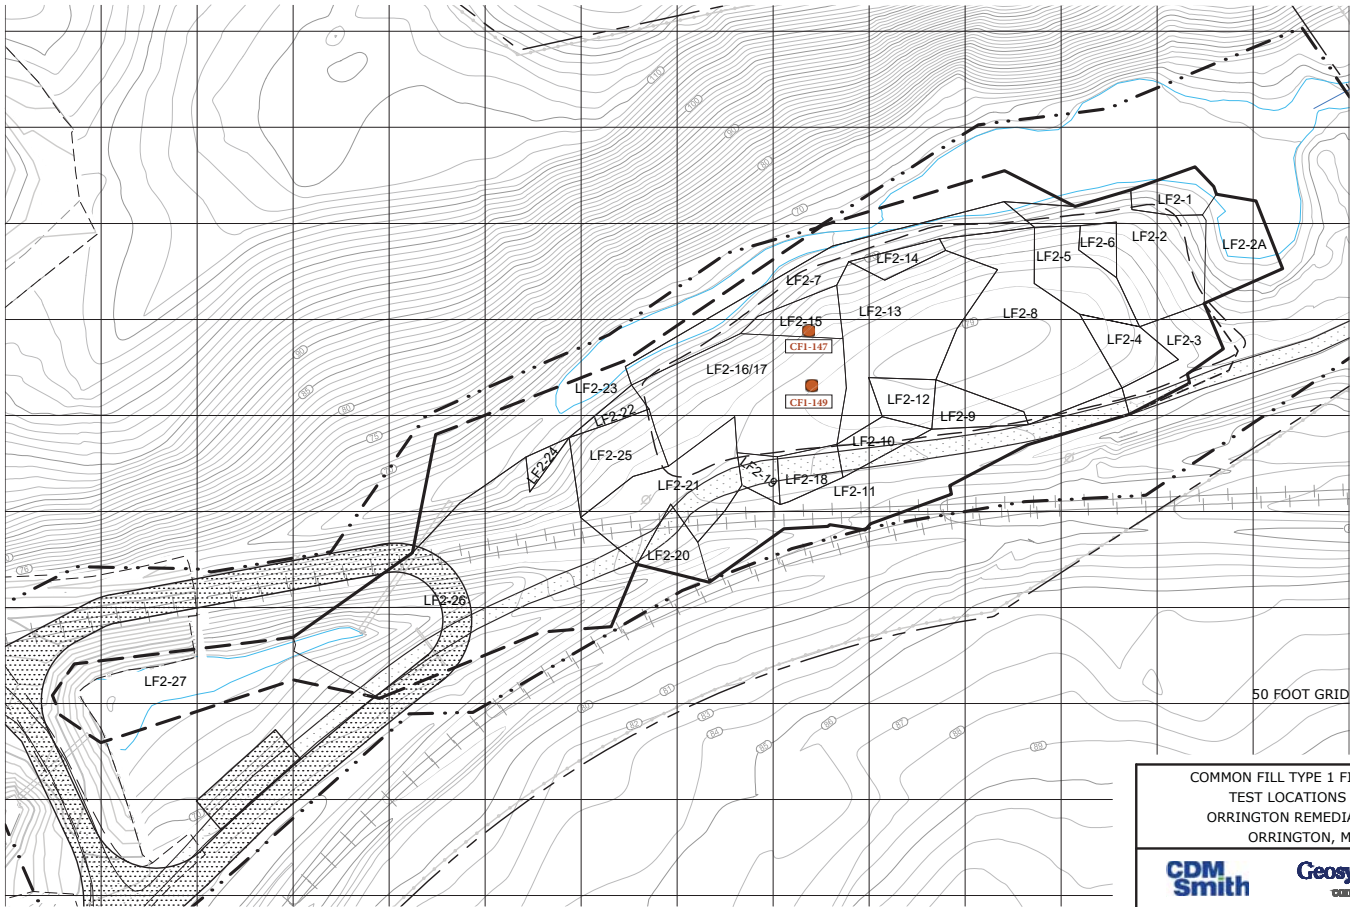
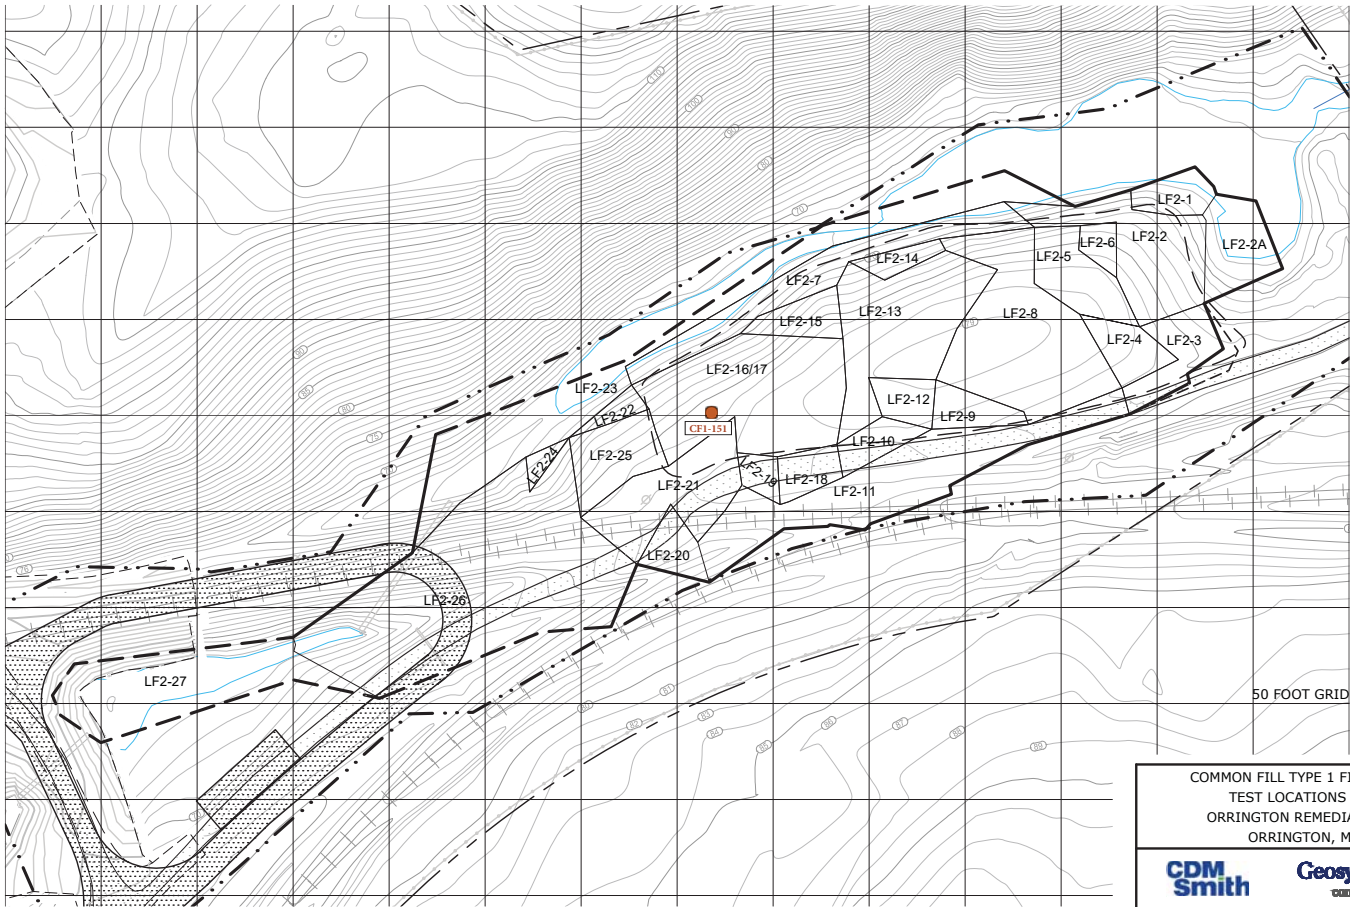
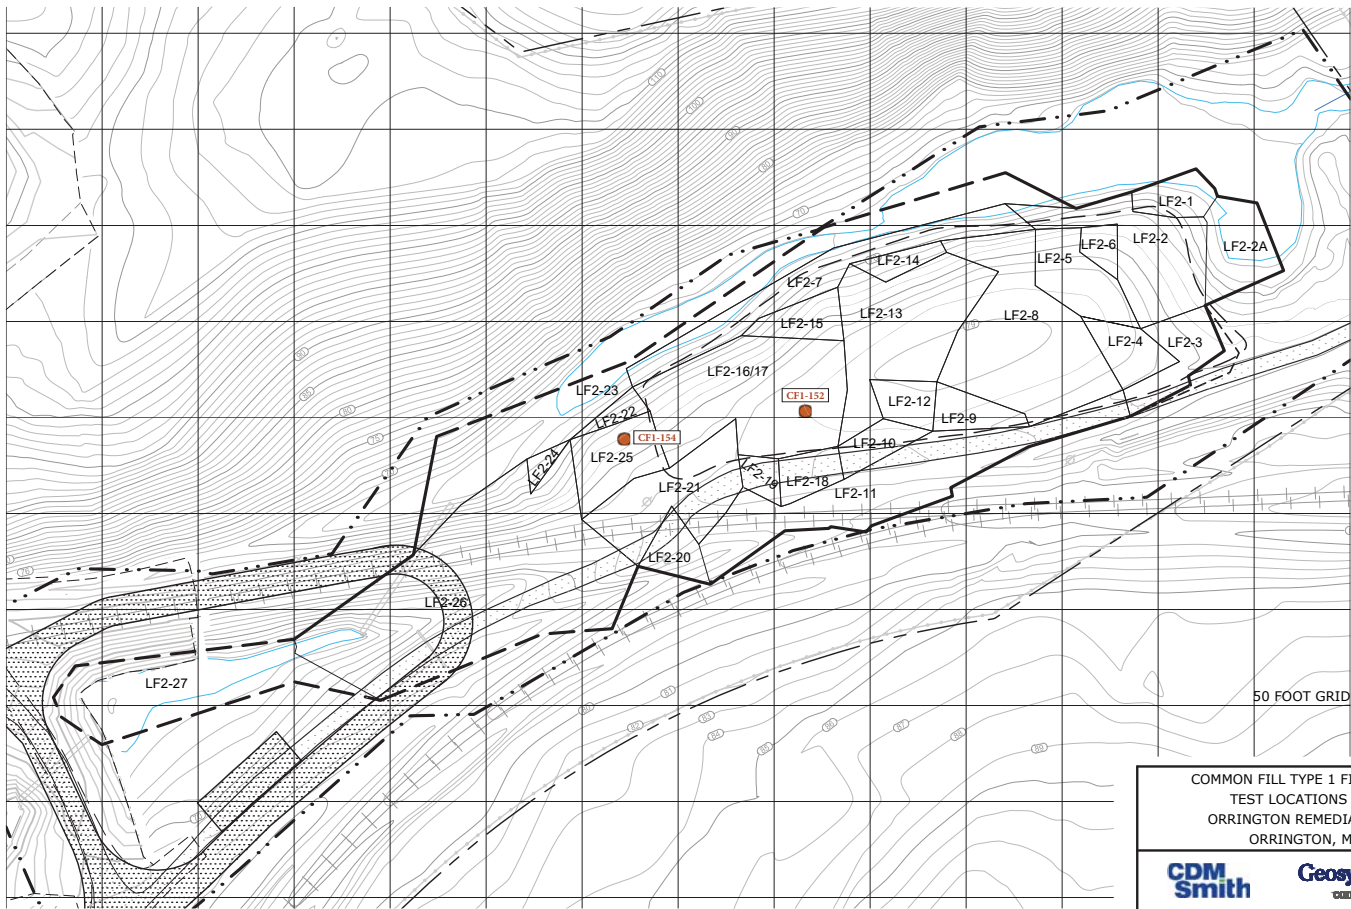
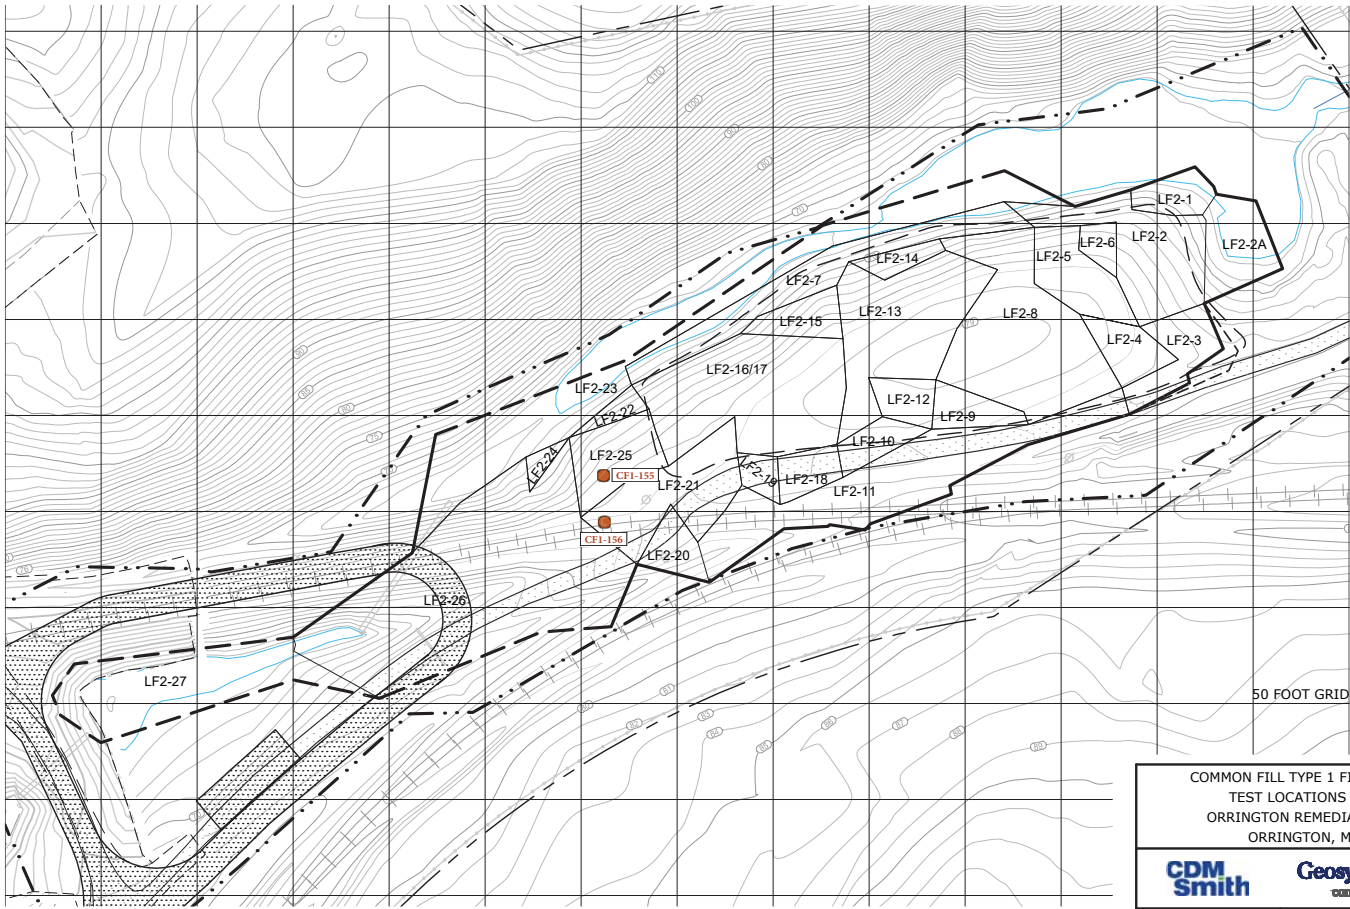
1. Retest indicates the previous test failed compaction. Retests corresponding to a failed density test are listed in order below the first failed test until a "Pass" result is obtained.
2. For locations where compaction does not meet specification (e.g., Failed locations), material was recompactd using vibratory smooth drum roller.
3. Due to low compaction results in LF2-26, Charter collected a new proctor (LF2-CF1-007). See DFR dated July 27, 2017. Previously failing tests on 7/27/17 passed based on the results of the new proctor and are included in Figure 4-3.

the lift failed a third time, then the lift was removed, and new material was placed in the subject area and recompact before retesting.
