Ref.: Results of Investigation of Landfill #2 at the HoltraChem Manufacturing Company
RCRA Corrective Action Site, Orrington, Maine.

Subject: Landfill #2 Investigation Results
HoltraChem Manufacturing Site
Orrington, Maine

The purpose of this letter report is to provide the results of the Landfill #2 Investigation for the HoltraChem Manufacturing Company, Orrington, Maine. This investigation was conducted from August 15 through August 18, 2000, to assess groundwater conditions in the vicinity of Landfill #2.

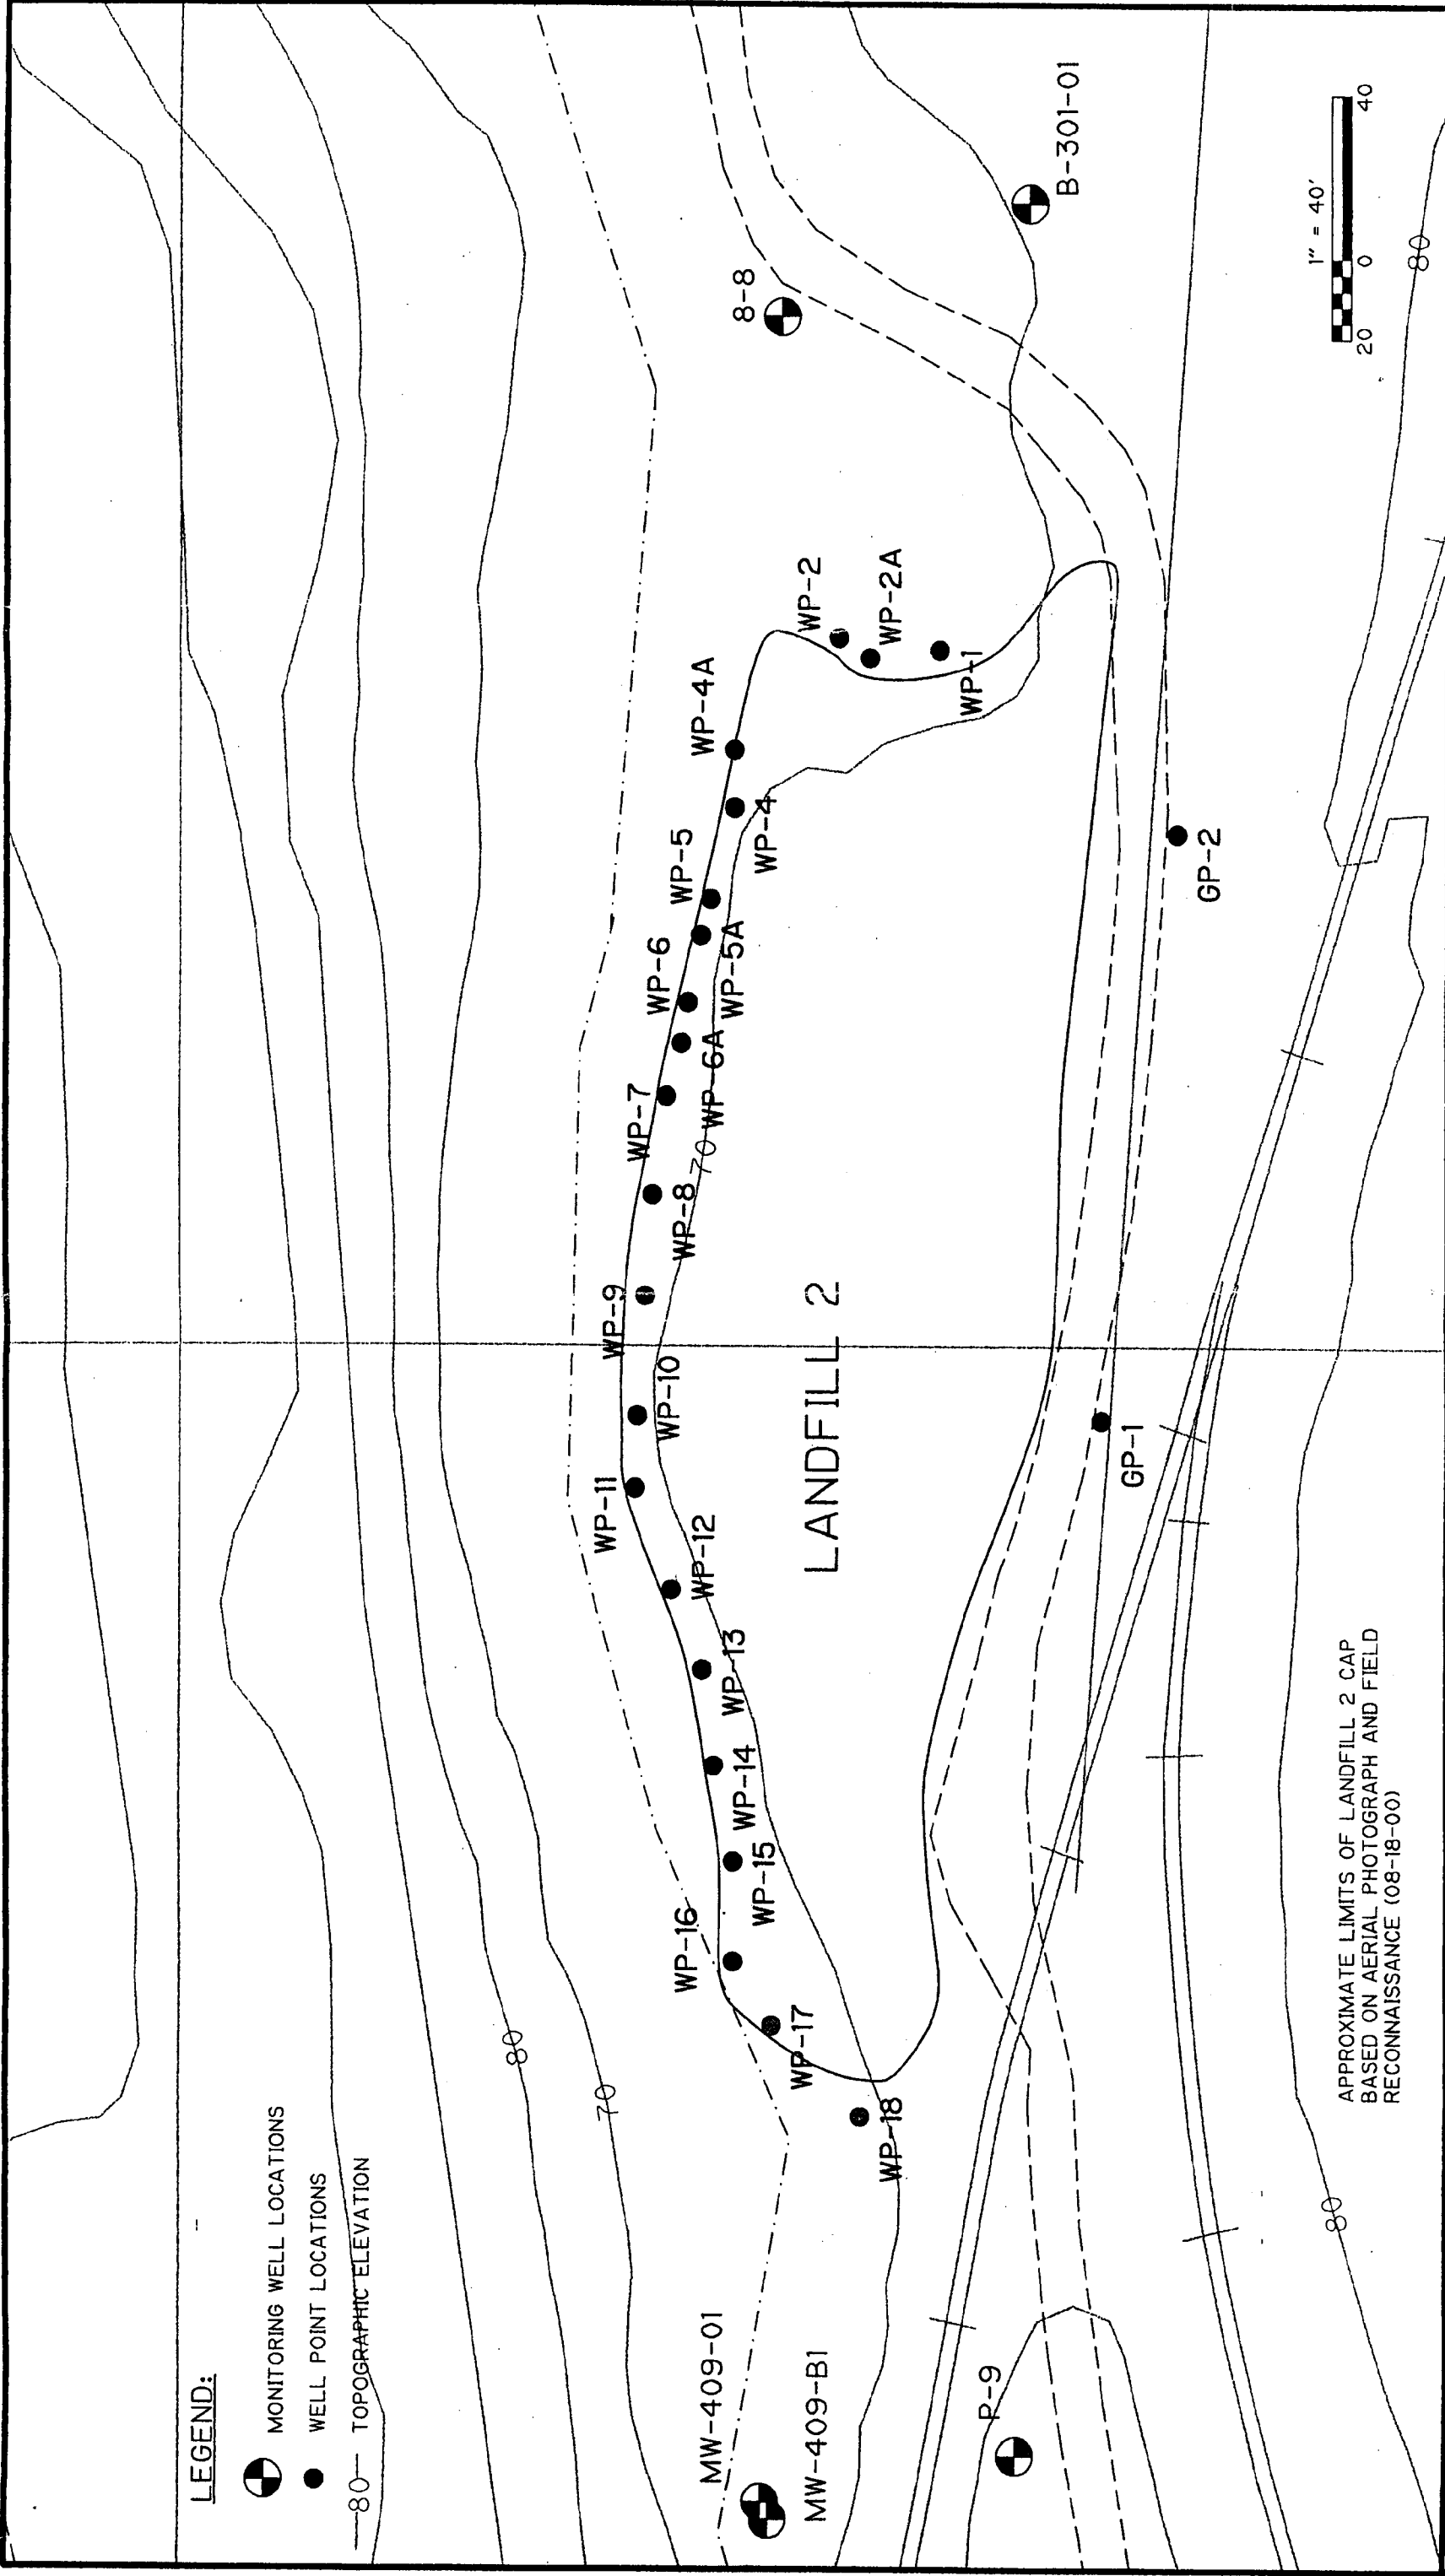
FIGURE 2

To evaluate the groundwater conditions and potential for leachate breakout from Landfill #2, a series of Geoprobe driven well points and piezometers were installed. The locations of the well points and piezometers are shown on Figure 2. Geoprobe services were provided by Acheron Geoboring Services of Falmouth, Maine. Subsurface conditions were documented during the installation of the Landfill #2 perimeter wells.

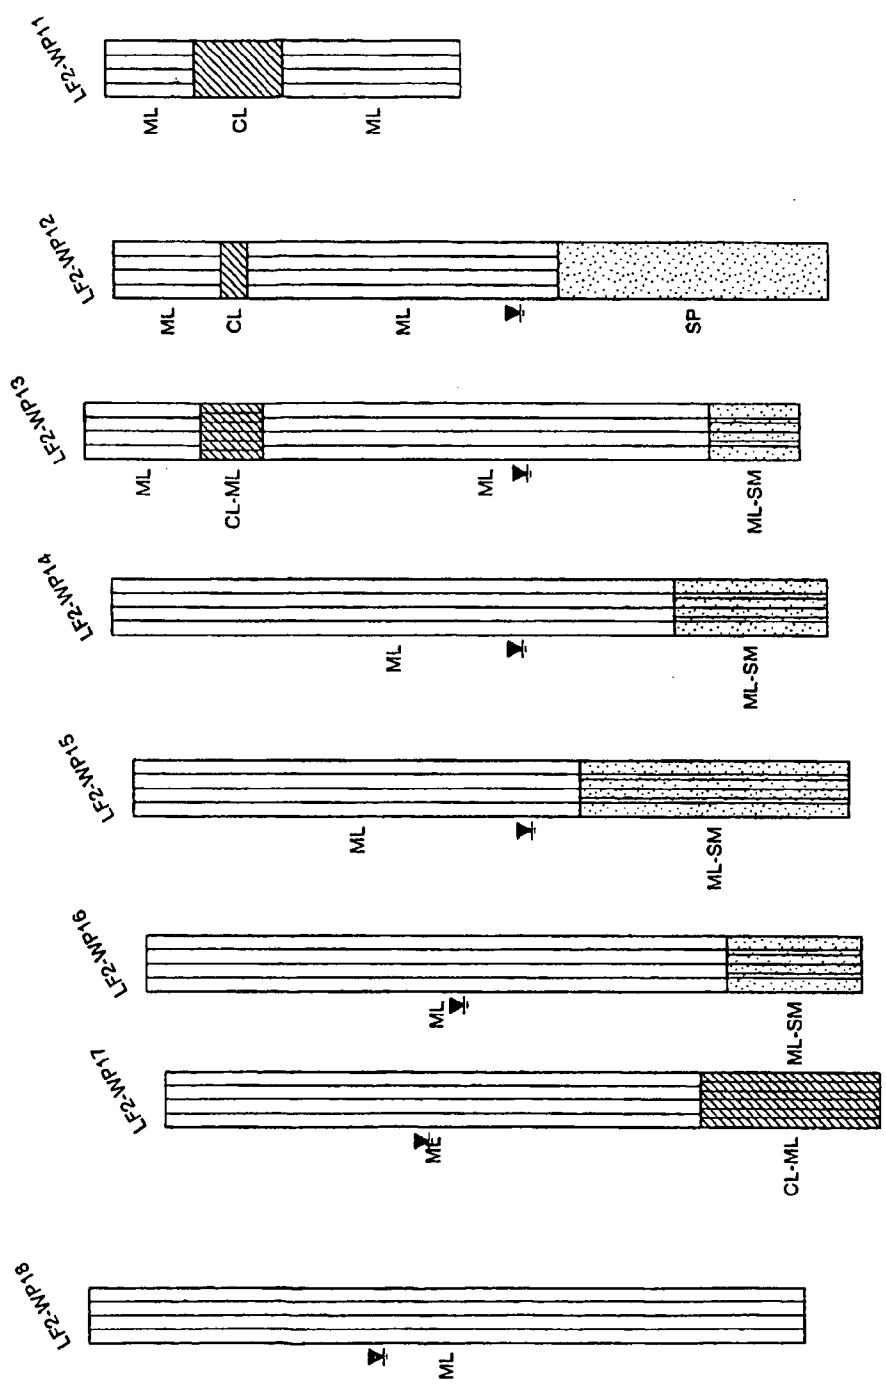
Figure 4

Geologic and hydrogeologic data were combined to provide an interpretation of the factors that control groundwater flow. Well point and piezometer logs, with graphic representations of subsurface conditions are attached as Attachment A. Cross sections illustrating subsurface conditions from west to east along the northern perimeter of Landfill #2 were generated. The cross section locations are illustrated in Figure 3 and the cross sections are presented in Figures 4, 5 and 6.

The surficial soils along the perimeter of Landfill #2 consist of brown silt with little coarse to fine sand. The surficial soils are generally 0.5 feet to 1 foot thick. The overburden deposits can predominantly be characterized as silt. To the north and northeast, the silt deposits are overlain by a dark brown, soft, clay layer. The thickness of this layer is generally 0.5 to 1 foot thick and is encountered at approximately 1 to 2 feet below ground surface (BGS). To the northwest, sandier deposits are encountered below the silt at approximately 5 to 7 feet BGS. Based on boring logs for B-301, and the shallow borings advanced during this investigation, soils below the landfill consist of dense silt (glacial till).

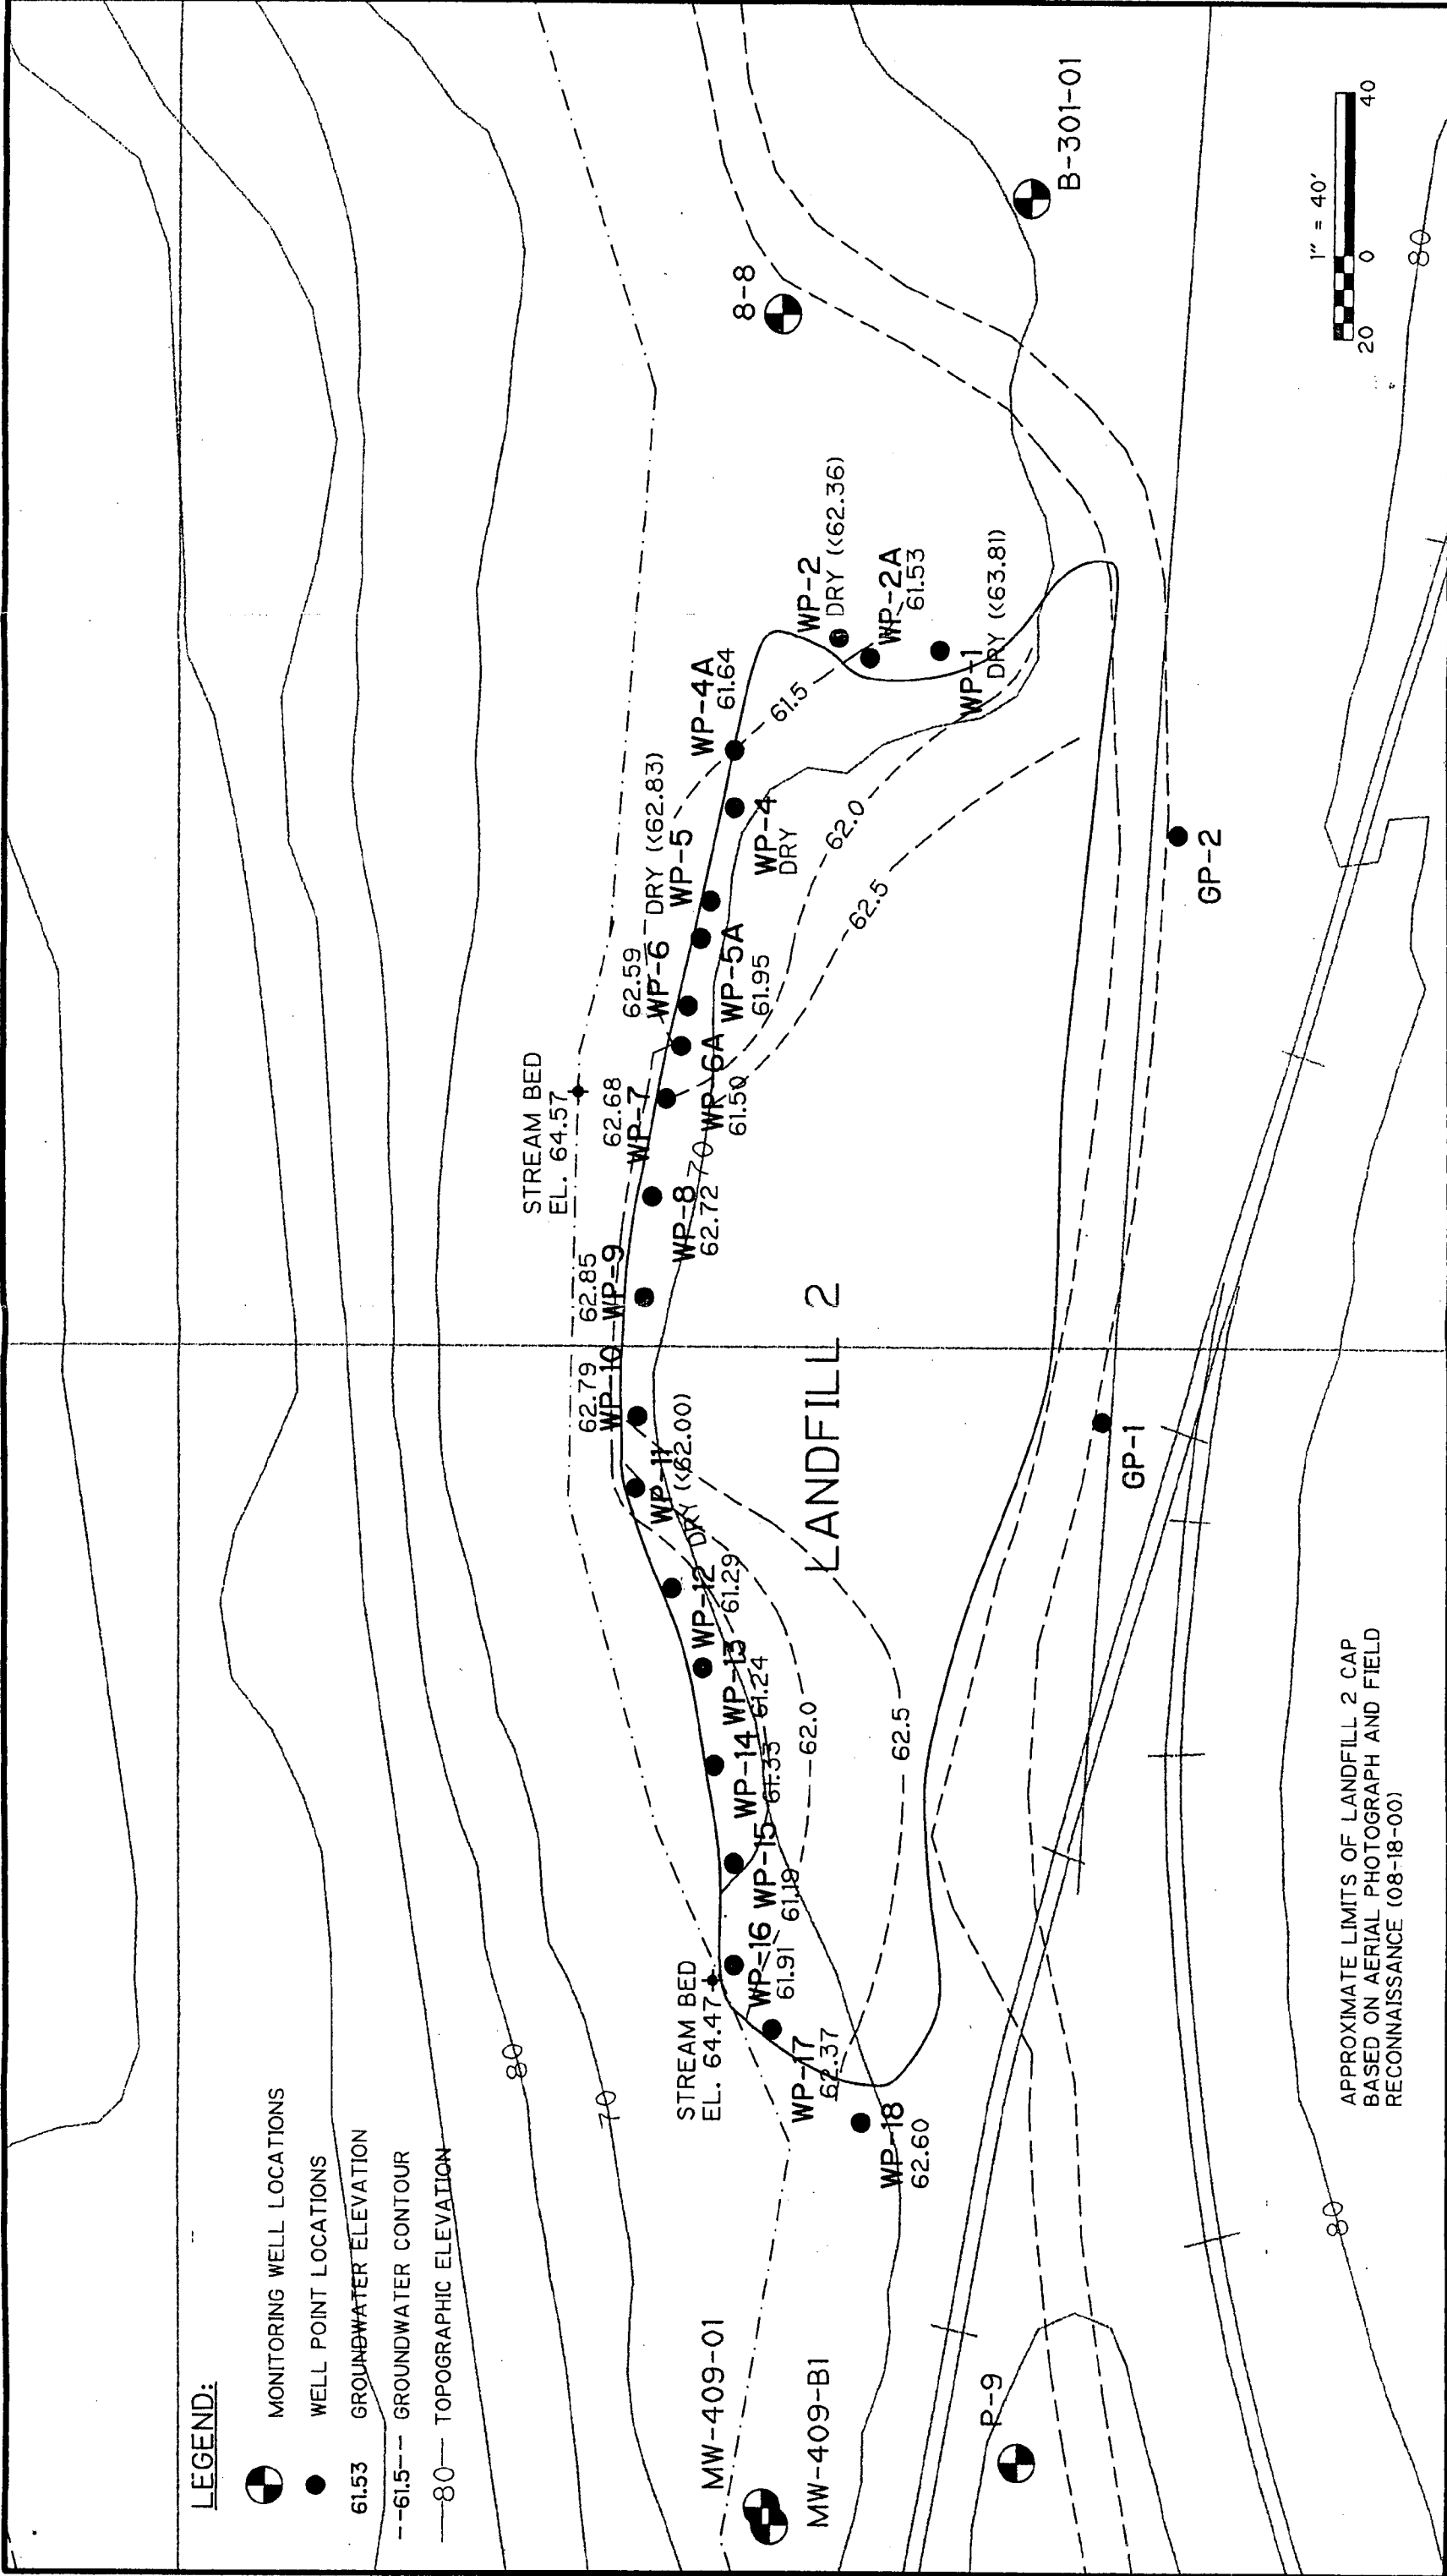
FIGURE 7

Water level measurements were collected from all newly installed well points and piezometers on August 8. Groundwater elevations are reflective of the amount time wells were allowed to equilibrate following installation (between approximately 12 and 48 hours). Although wells with higher and lower head were observed adjacent to each other, there were no impermeable layers observed which would suggest that a perched water table exists here. Groundwater elevation data is summarized in Table 1. Geologic and hydrogeologic data were combined to provide an interpretation of groundwater flow direction. Figure 7 presents a groundwater contour map for Landfill #2.

In general, groundwater elevations are higher in the northern central portion of the landfill and lower in the northeastern and northwestern areas. Groundwater elevations range from approximately El. 61.19 at LF2-WP15 (northwest) to El. 62.85 at LF2-WP9 (central) to El. 61.53 LF2-WP2A (northeast). Hydraulic gradients indicate that groundwater generally flows to the northeast and northwest. The presence of the clay layer just above the water table along the northern central portion appears to restrict flow

Hydraulic gradients indicate groundwater flows to the northeast and northwest of the landfill. Field parameters and analytical results were generally highest in well points located along the northwestern perimeter of the landfill. These elevated constituents indicate that groundwater in the northwestern portion of the landfill is impacted by sodium and chloride from the brine sludge fill material. Although total mercury was detected in three samples, none of the groundwater samples contained detectable concentrations of dissolved mercury. Due to the dry streambed, surface water samples were not collected with which to assess the impact on the observed groundwater conditions on the Southerly Stream. However, the absence of dissolved mercury in groundwater samples indicates that Landfill #2 is not an ongoing source of mercury to the Southerly Stream
