RE: MDEP Acceptance of Landfill Ridge Area Closure Report dated February 3, 2017

Mallinckrodt US LLC

Table 4-5C - Onsite Reuse Material Field Density Tests
Landfill Ridge Area
Orrington Remediation Site
Orrington, ME

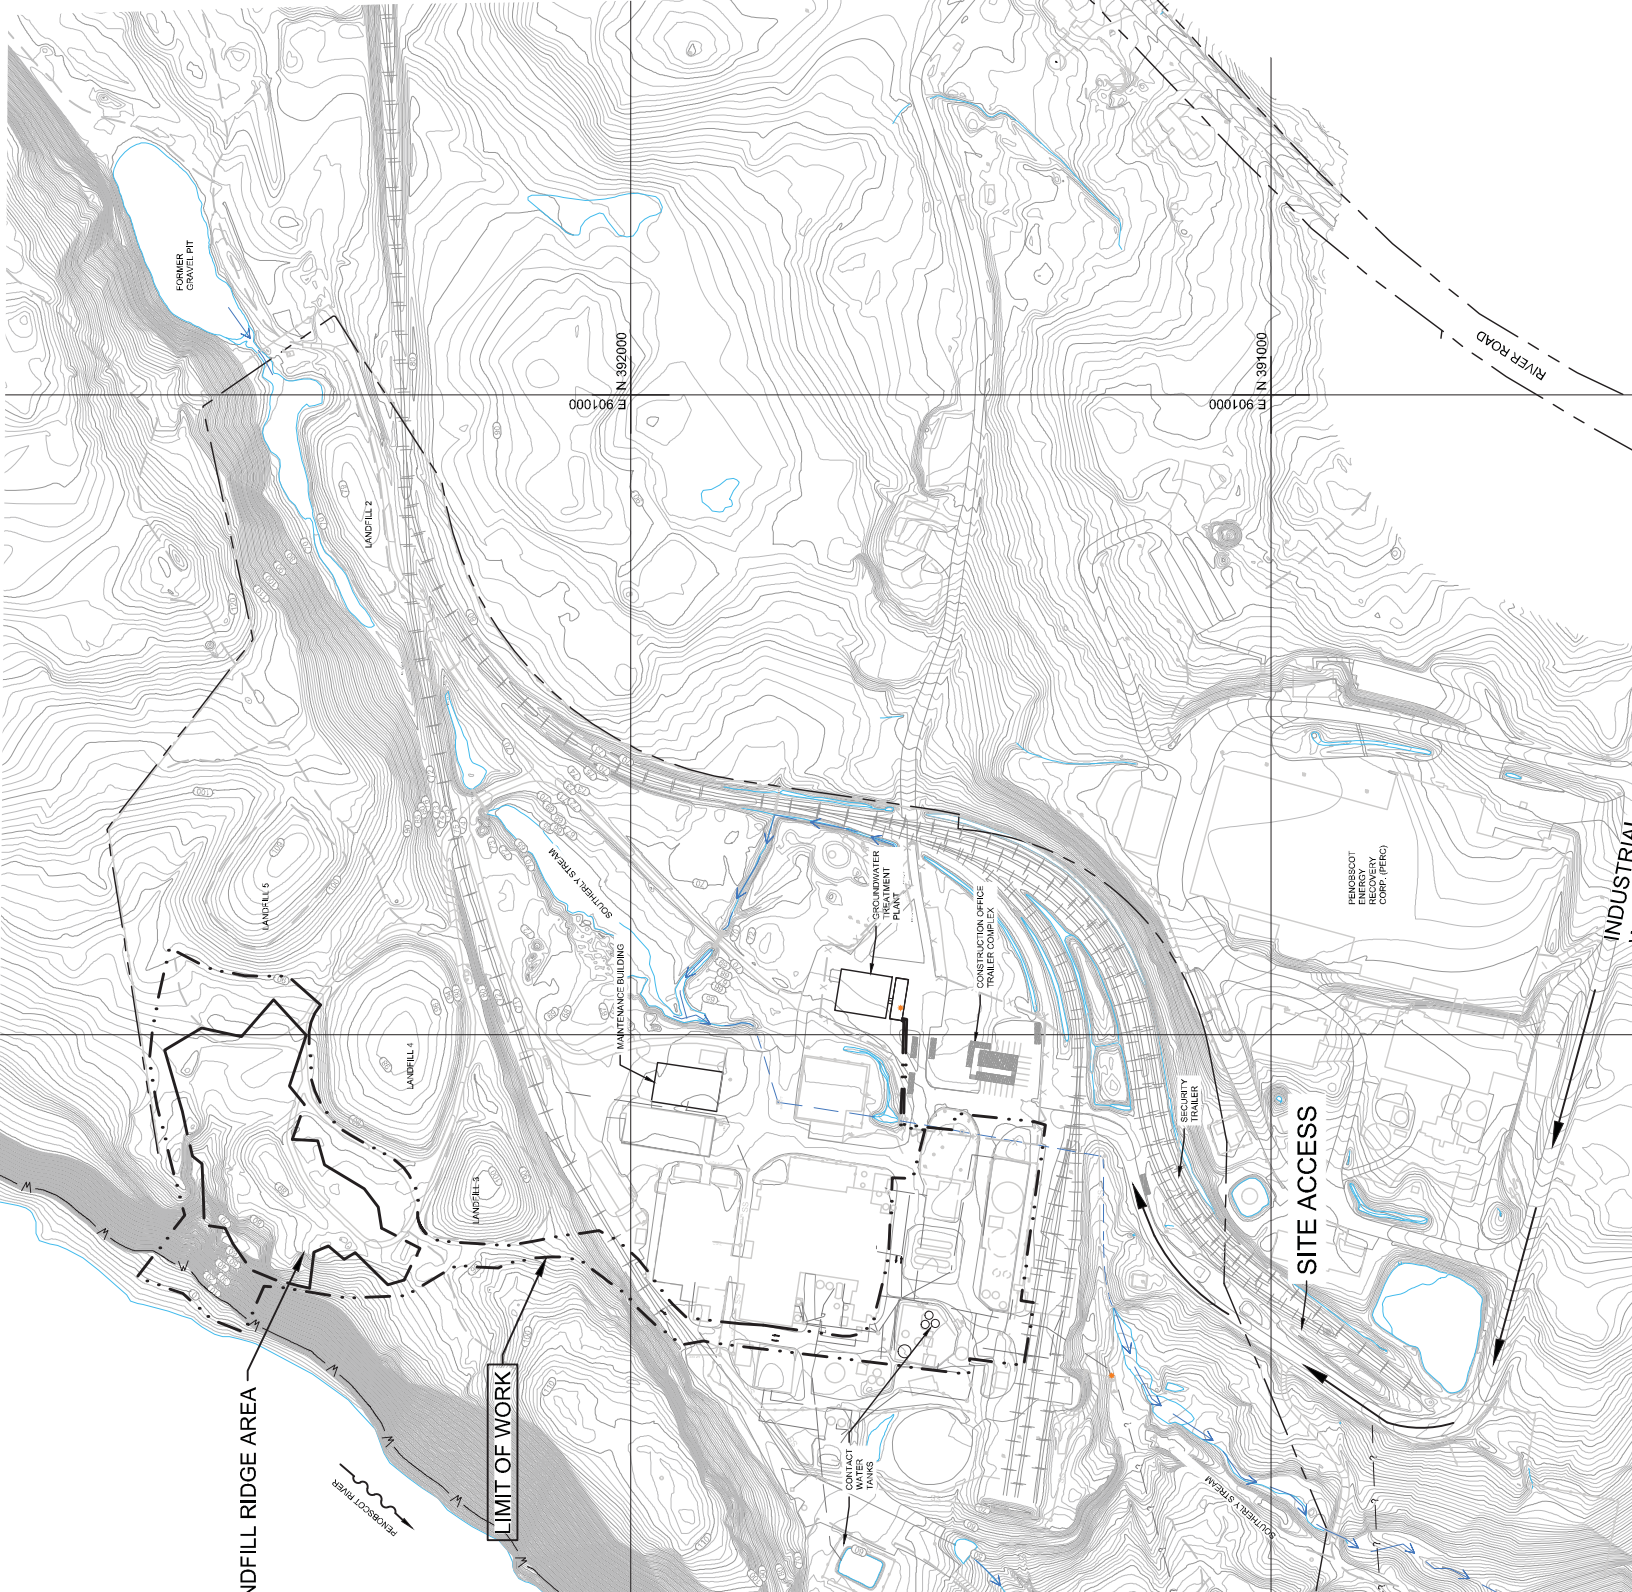
1. THE SITE IS LOCATED AT 99 INDUSTRIAL/
2. EXISTING TOPOGRAPHY AND SITE FEATURES WERE OBTAINED FROM AERIAL PHOTOGRAPHY CONDUCTED BY THE JAMES W. SEWELL & ASSOCIATES, INC. (JWS&A) IN 1984. THE VERTICAL DATUM IS NAVD 83 (NORTH AMERICAN DATUM 1983). THE VERTICAL DATUM IS NAVD 88 (NORTH AMERICAN DATUM 1988).
3. HISTORICAL INVESTIGATION LOCATION INFORMATION WAS OBTAINED FROM VARIOUS HISTORICAL SOURCES.
4. THIS FIGURE WAS ADAPTED FROM FIGURE 1 OF THE SITE INVESTIGATION REPORT DATED 2015.
